# SALT MARSH & COASTAL BANK RESTORATION

## Coastal Residence Darien, CT

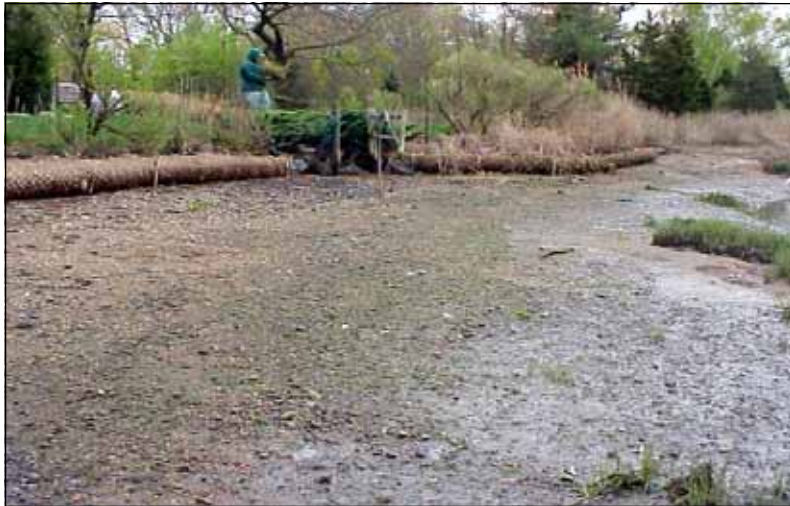
Existing conditions prior to replanting *Spartina alternifolia*. The coir fascines installed along the bank by NEE are visible in this photograph.

- Installed 100 ft. of 16" coir fascines along the tidal bank to eliminate shoreline erosion.
- Restored a 1,700 square ft. salt marsh flat.
- Planted 1,700 salt tolerant herbaceous plants.
- Controlled invasive *Phragmites australis* located on site.
- Installed native salt tolerant shrubs on the tidal bank.

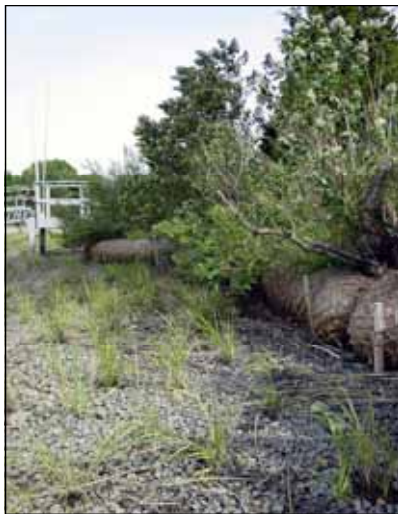
Coir fascines, with adjacent *Spartina alternifolia* plantings.

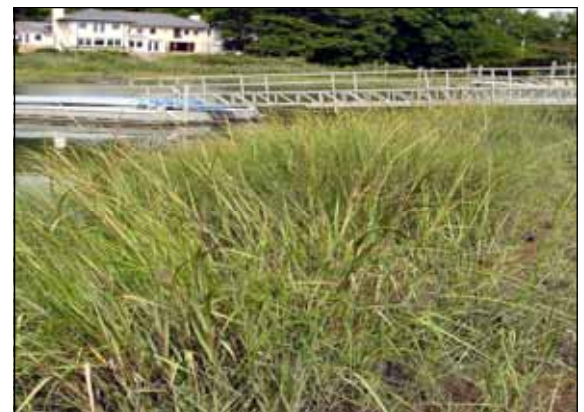
*Spartina alternifolia* plantings thriving within the salt marsh

- *Spartina alternifolia* plantings colonized the tidal marsh restoring the area of impact within two years of the site work.
- Erosion on site was significantly reduced with the use of the coir fascines along the tidal bank.
