SALT MARSH & COASTAL BANK RESTORATION

Coastal Residence Darien, CT

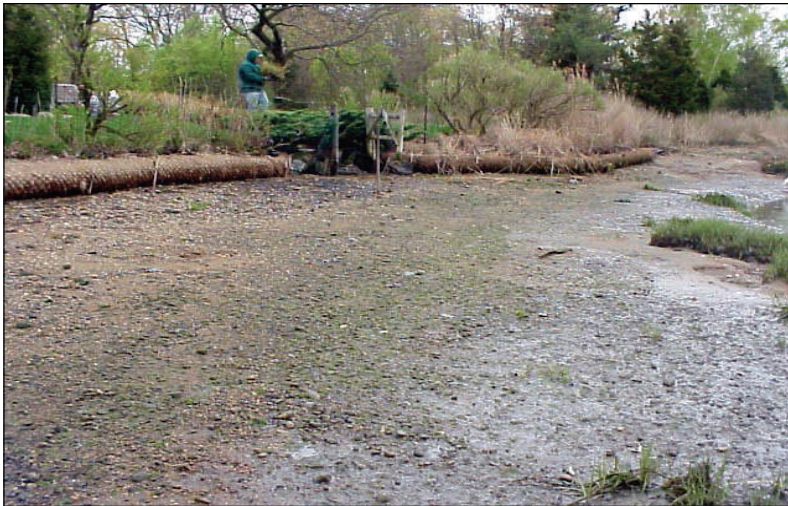
Existing conditions prior to replanting *Spartina alternifolia*. The coir fascines installed along the bank by NEE are visible in this photograph.

- Installed 100 ft. of 16" coir fascines along the tidal bank to eliminate shoreline erosion.
- Restored a 1,700 square ft. salt marsh flat.
- Planted 1,700 salt tolerant herbaceous plants.
- Controlled invasive *Phragmites australis* located on site.
- Installed native salt tolerant shrubs on the tidal bank.

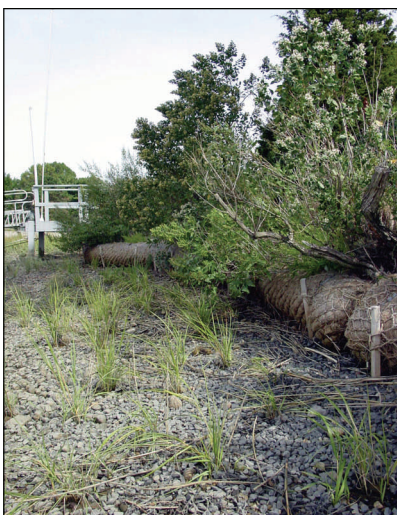
Coir fascines, with adjacent *Spartina alternifolia* plantings.

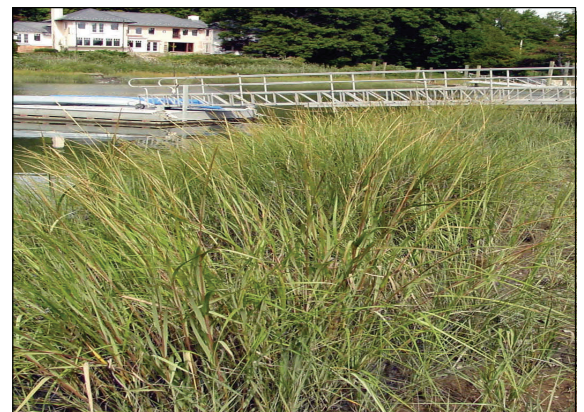
Spartina alternifolia plantings thriving within the salt marsh two years after construction.

- *Spartina alternifolia* plantings colonized the tidal marsh restoring the area of impact within two years of the site work.
- Erosion on site was significantly reduced with the use of the coir fascines along the tidal bank.
