UST REMOVAL & LIMITED REMOVAL ACTION (LRA)

Historic Commercial Property Northampton, MA

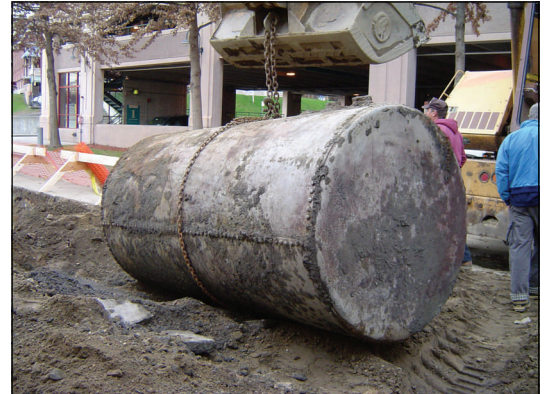
NEE personnel observed the removal of the 1,000-gallon fuel oil UST and the excavation of impacted soil. The riveted steel tank appeared to be good condition, with no visible holes, or locations of leakage along the seams. There did appear to be “overfill” conditions around the fill and vent pipes. PID field screening of the overfill-impacted soil indicated 230 parts per million (ppm) total volatiles in the headspace. Since this sample was collected within 10 feet of a UST, and was over 100 ppm, it triggered a **120-day release notification** requirement to the DEP.

A 54-inch by 8'-8" riveted steel #2 fuel oil underground storage tank being removed.

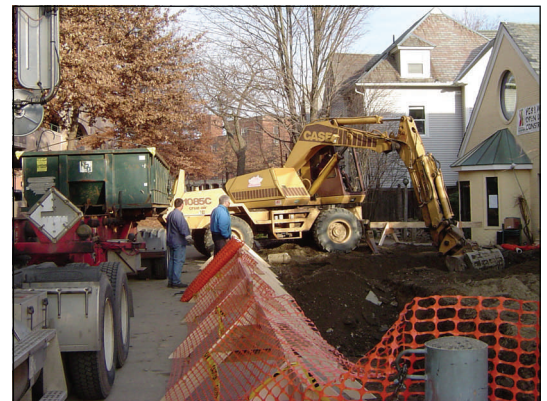
Excavation of oil-impacted soil into roll-off containers.

Under the **Limited Removal Action (LRA)** provision of the MCP, excavation and off-site disposal of up to 100 cubic yards of petroleum impacted soils are allowed for 120-day release conditions. Approximately 40 cubic yards of impacted soil were temporarily stored in roll-off containers until transportation and ultimate disposal at an asphalt batch facility were arranged. NEE coordinated soil excavation activities, including preparation of a Bill-of-Lading.

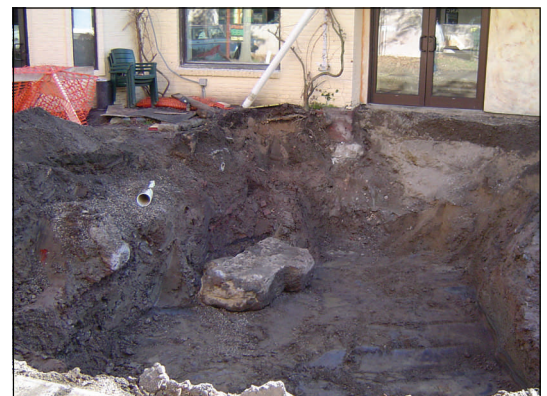
The UST grave after soil excavation and confirmatory sampling.

Confirmatory samples were collected at the base of the excavation near each end of the former tank, and on the sidewalls of the excavation. PID Field screening results indicated all of the confirmatory samples contained less than 10 ppm total volatiles. Laboratory results confirm that the remediation was effective as all analytes were at concentrations below the laboratory reporting limit; not detected. NEE prepared a **UST Closure Report** documenting completed activities in compliance with State and local regulations.
