COAL TAR REMEDIATION

Liberty Street
Easthampton, MA

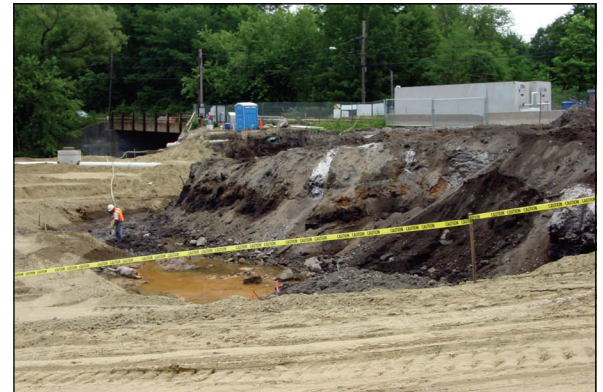
Removal of coal tar deposits from the isolated pond.

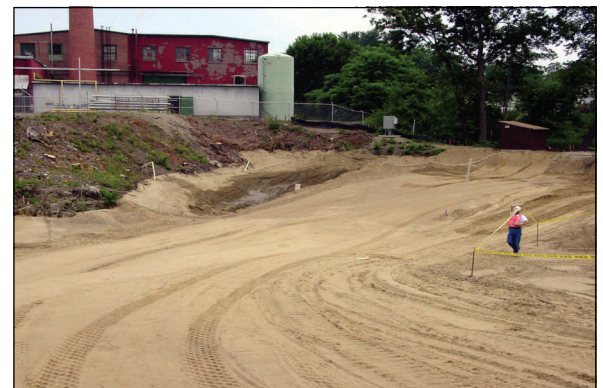
Condition of the isolate pond area following excavation of impacted soil and re-grading.

Prior to NEE's site work, the contaminated soil was excavated and removed by the site contractor. NEE then installed 7,000 wetland and upland plants, as specified on the remediation site plan. Native seed mixes were also sown by NEE throughout the disturbed area. The portion of the contaminated site that was formerly an isolated pond was restored by installing native aquatic plants.

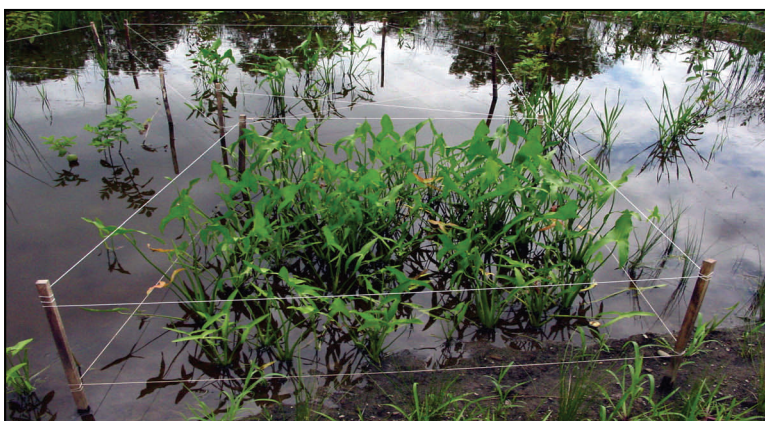
NEE installed native wetland plants, including *Sagittaria latifolia*, within the isolated pond. Temporary wildlife fencing was placed around each aquatic plant bed to prevent predation by waterfowl until the plants were fully rooted.

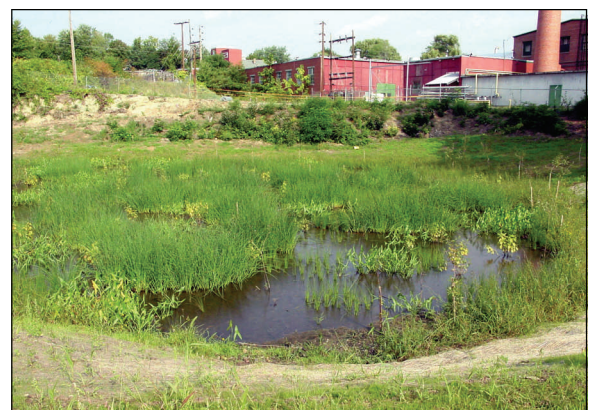
Conditions within the restored isolated pond one year after planting.
