# BANK RESTORATION & BIOENGINEERING

Osage River  
Eldon, Missouri

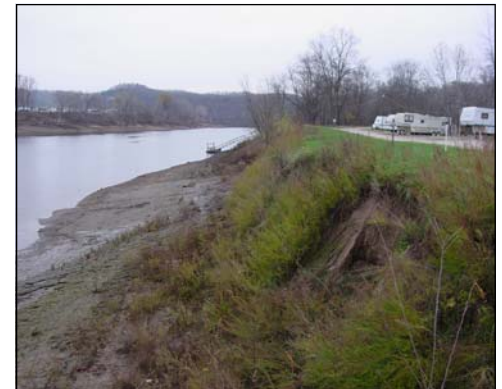
Eroded bank prior to site excavation.

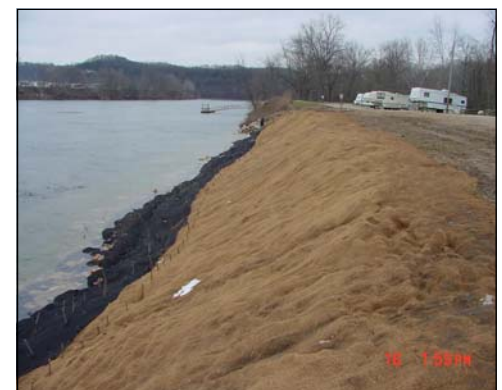
Re-graded bank with permanent erosion control fabric and biodegradable erosion control blanket along the slope.

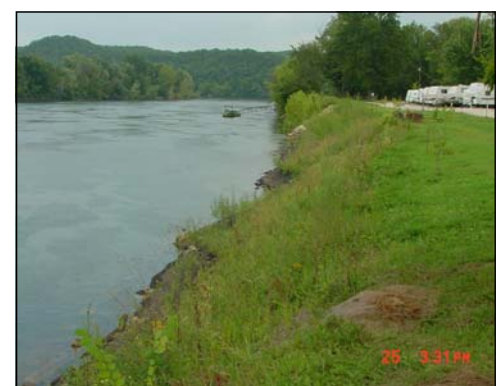
Stabilized bank one year after restoration.
